Facilities Master Plan  
2013

Prepared by:  
Dille & Traxel, LLC  
Architecture and Planning  
4061 Highway PP, Ste. 2  
Poplar Bluff, MO 63901

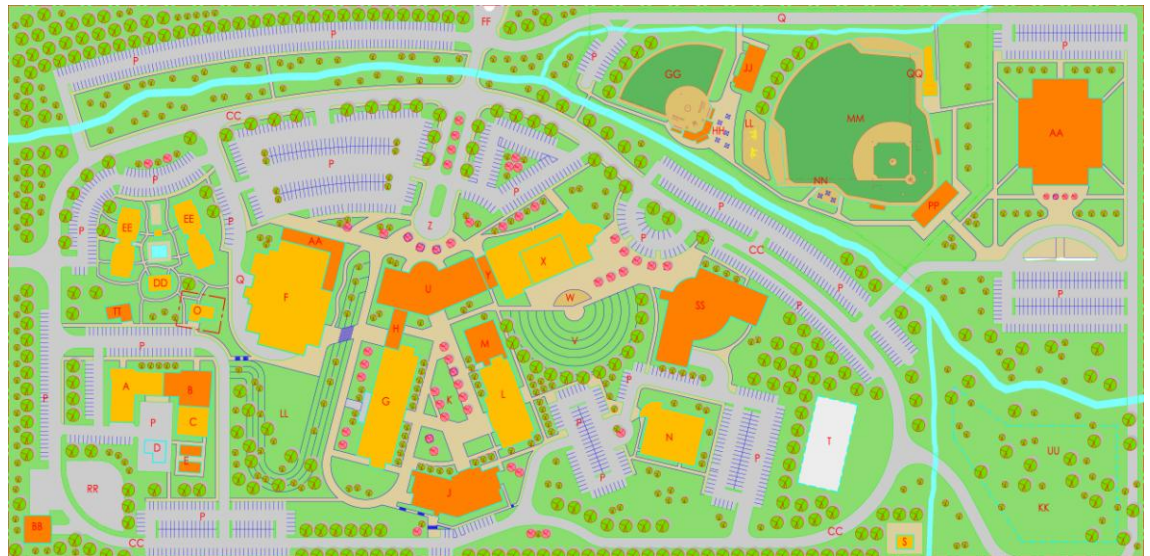
The site plan below (see appendix for larger size) has been created to meet the growing needs of the college. It shows the location and proximities of existing to new buildings, parking, and traffic ways. Existing buildings are shown in yellow, proposed buildings in orange.

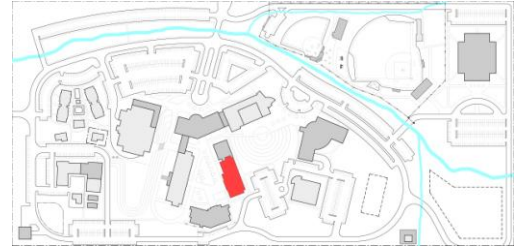
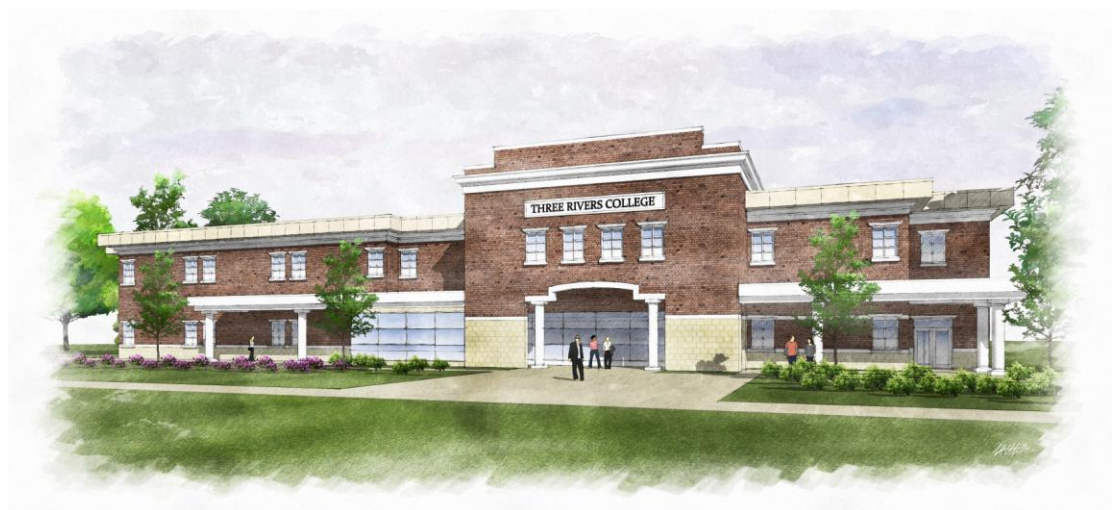
## 1. Academic Resource Commons

The Library will remain in the building and the additional space will be occupied by relocating the Tutoring Center and Student Support Services. Other spaces will include student collaboration study rooms, an Educational Resource Library, and open computer areas. A coffee shop is also integrated into the design of the building.

The exterior is to receive a complete renovation creating a new character that is to set the standard for future campus construction. Brick and stone cladding on all sides, a new entry element, and covered canopies help soften the appearance. Windows are to receive muntins and trim to match the character of the new cornice.

This project is to be the first phase of the "Academic Triangle" encompassing the existing Westover Building and a new classroom building.

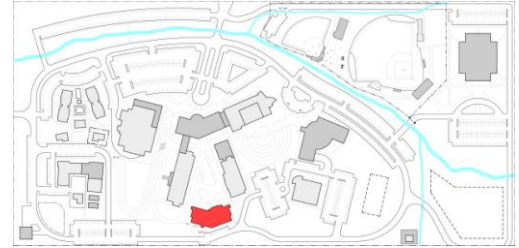
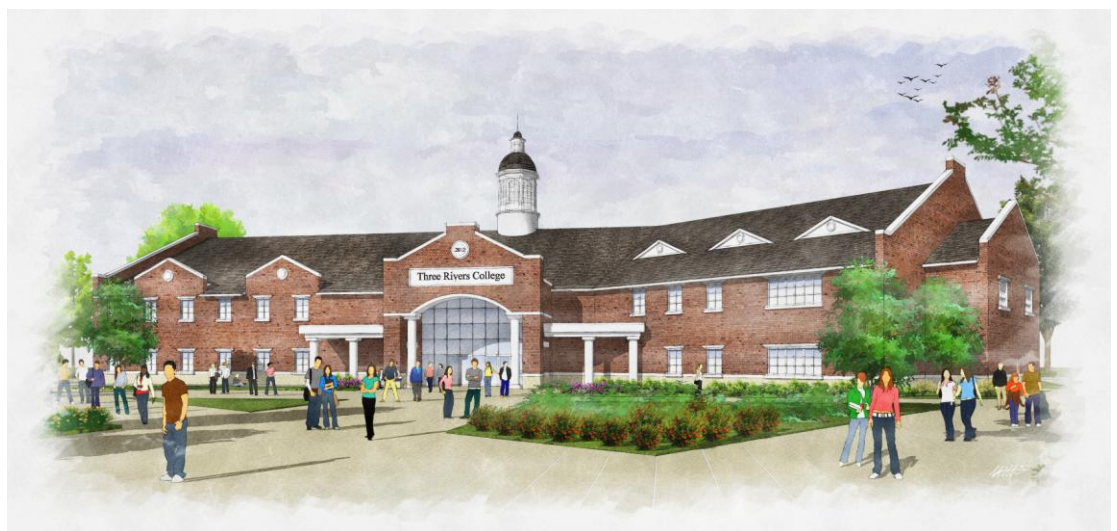
## 2. Classroom Building

The location for a new classroom building was chosen based on the location of several existing academic facilities. This building, along with the existing Westover Classroom building and the Academic Resource Commons, would form a new "Academic Triangle". The space between these three buildings would be an outdoor green space used by students and faculty as a pedestrian friendly gathering area.

The new classroom building would anchor the "Academic Triangle". It needs to house approximately 40,000 square feet of new classrooms, offices, and lecture halls to properly serve the future needs of the college.

Exterior design of the building is to match the standards set by projects in Phase 1 of this Master Plan. Cohesive exterior materials and design traits are important for the campus image, to provide the best student, faculty, and visitor experience the college can offer.

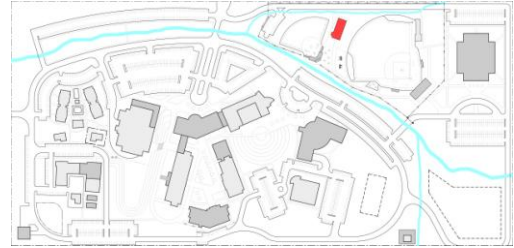
### 3. Softball Building

The new home for the Lady Raiders softball team will be located next to the softball field. It will provide a new coach's office thus freeing up space in the BAC for other uses.

A storage area for field maintenance equipment will have an overhead door for easy access. The locker room will provide space for up to 20 players and restroom and laundry facilities. A large multi-purpose room will be used for pitching and hitting drills during times of inclement weather.

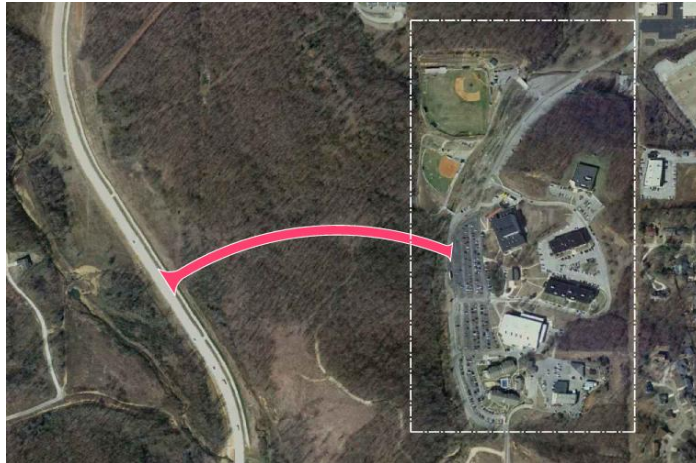
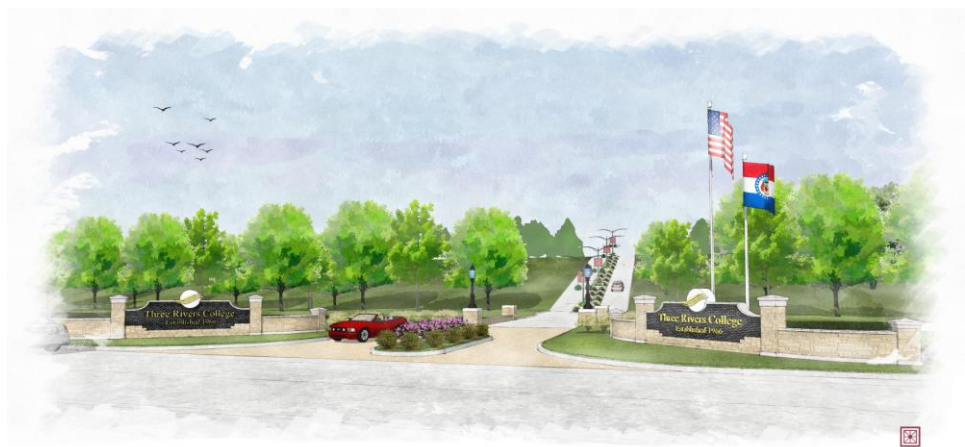
#### 4. Entrance Road

There are currently two vehicular entrances to the college. The one from the northeast corner was constructed first when the campus opened in 1978. It comes from Business Highway 67 and is not well defined as a front door. Its understood circulation pattern causes visitors confusion. The entrance from the south was expanded to a usable road in the 1990's and leads to State Highway PP. This entrance is also rather convoluted as it approaches the campus in what feels like a back door. Neither road could be categorized as a satisfactory approach to the college campus and neither one provides a focused pathway that is easily broached.

A new expanded entrance is much needed for Three Rivers. Through a land donation, a corridor has been given to the Three Rivers Endowment Trust to construct a new entrance from the west to Shelby Road. This is a much better location to enter the campus as it leads directly to the center of activity and large parking area. The road should be designed as a boulevard, one that expresses the image of character and class that the college would like to portray to the public.

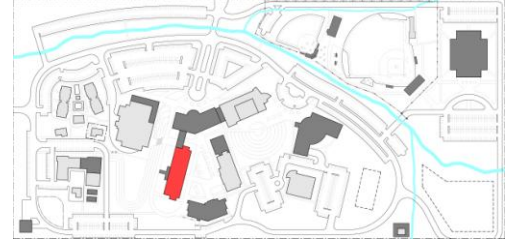
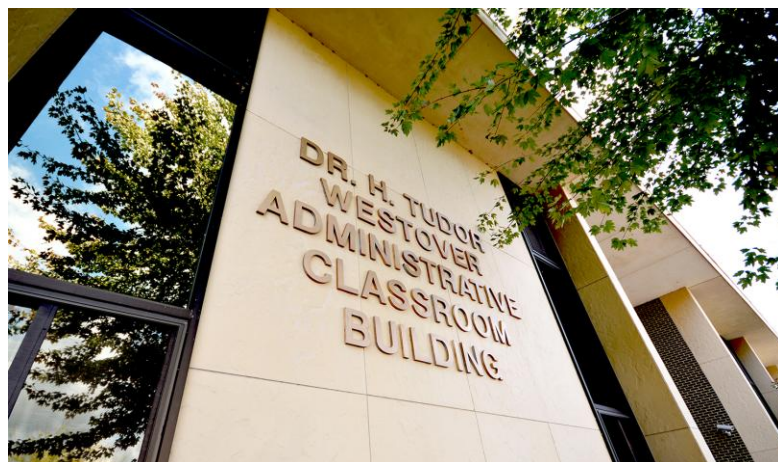
## 7. Westover Building - Renovation

The Westover Building was built in 1978. The building provides almost 60,000 ft<sup>2</sup> of space and is in mostly sound working order mechanically. The original boiler/chiller systems have been replaced and the electrical system and plumbing appear to be adequate for future use.

The pertinent issues with the Westover building are a matter of functionality for the future plans of the College. In addition to the renovation of the Bess Activity Center as well as the construction of the new classroom building mentioned previously, the interior space of the Westover building will need reconfigured to provide the classroom and administrative space required. The restroom entrances do not currently meet ADA guidelines and will also need reworked. Traffic circulation will be redirected from the widely used west entrance to the front of the building as campus parking and overall traffic patterns are redesigned.

Cosmetically, the building is in need of an update as many of the fixtures and design elements are original to the building. The exterior of the building should be renovated to match the design elements of the other facilities that make up the aforementioned "Academic Triangle" consisting of the Library and new classroom building.

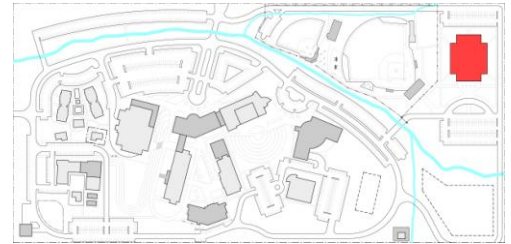
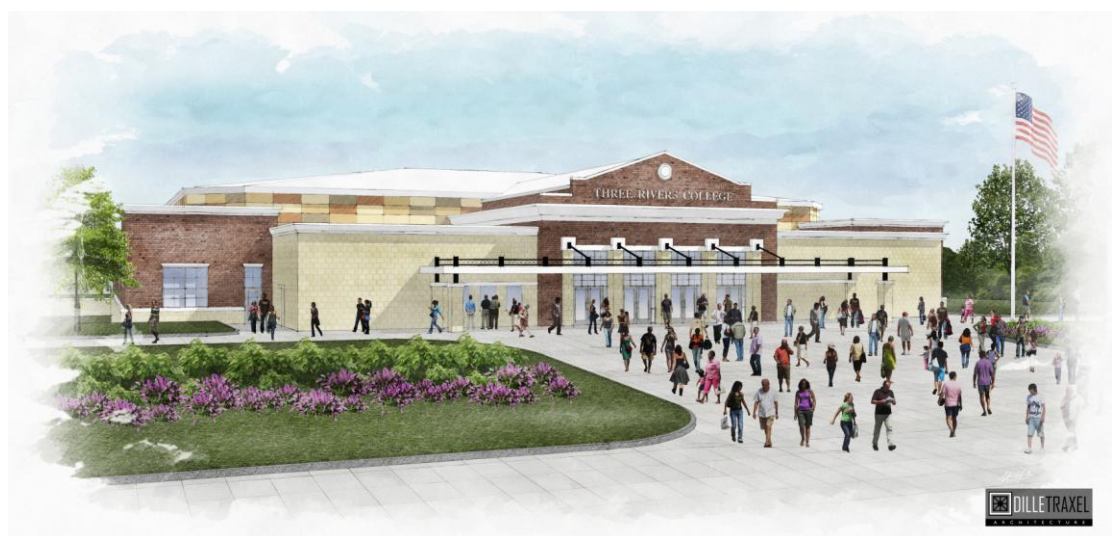
## 8. Event Center

This building was constructed as a temporary home for these programs that has now lasted over 30 years. These facilities do not provide adequate space for training, offices, or lockers for these teams to compete nationally. Of the five regional teams, Three Rivers has the smallest and most dated facility for training and games.

The basketball teams are the most community recognizable programs the college offers. Men's games often draw over 1,000 spectators. This number may increase should facilities allow. A new event center should be designed to house 2,000 to 3,000 seats, multiple locker rooms for all college teams and visitors, and ancillary spaces for concessions, merchandise, athletic classrooms, laundry, storage, etc. Box seating could be designed for income from local corporations.

This being the location community members will frequent the most, the design of this building should portray a positive image and connection to the rest of the campus. Adequate and well lit parking that is easily navigated as well as good building traffic patterns will be essential in the design of this facility.

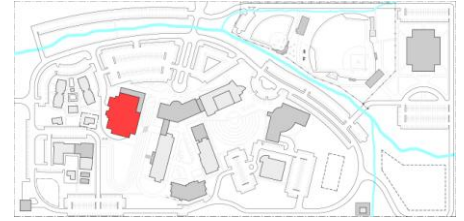
## 9. Conference Center

Once the athletic department vacates the existing Bess Activity Center, this building will be available for adaptive reuse. Due to a lack of campus space for large meetings, banquets, seminars, conferences, etc., a building the size of the BAC is needed.

The transformation of the BAC into a Conference Center would entail creating flexible sized banquet rooms in the existing gymnasium, adding new smaller meeting rooms, creating a full food service operation, and repurposing space for storage, administration, retail, and other uses.

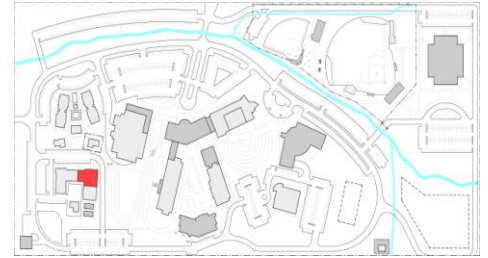
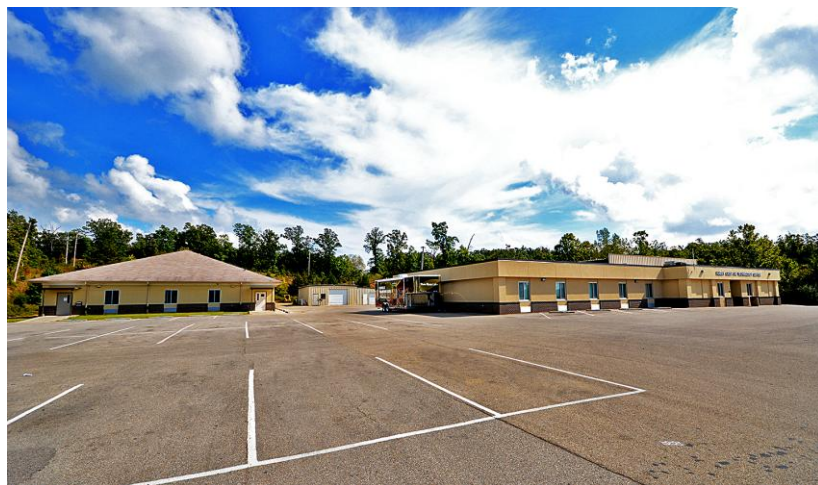
## 11. Crisp Center For Workforce Development

The current facility is at 100% capacity and, due to being constructed as an addition and renovation to an old maintenance shed, is completely inadequate as a high growth area. Area manufacturers and other employers are dependent on the college to not only provide them with a highly skilled workforce but also to provide state of the art continuing education facilities and technology programs for ongoing training as new technologies and other various needs arise.

An addition to the current Crisp Center can connect to a building previously used as a child care center to form a new Crisp Center for Workforce Development. This new facility would enable Three Rivers to expand its customized training and workforce development programs.

The new facility would be large enough to house a state of the art robotics lab, materials testing and fabrication facilities, and Agronomy and Ag Technology labs. All programs will be supported by software for CAD, simulation, cost estimating, project management, and technology based teaching modules. These computer labs should feature large scale digitizers, color printers and plotters, a high speed large format plotter, and 3-D modeling printer.

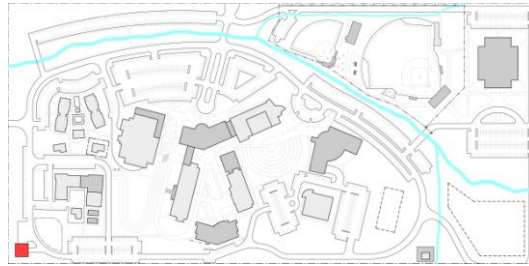
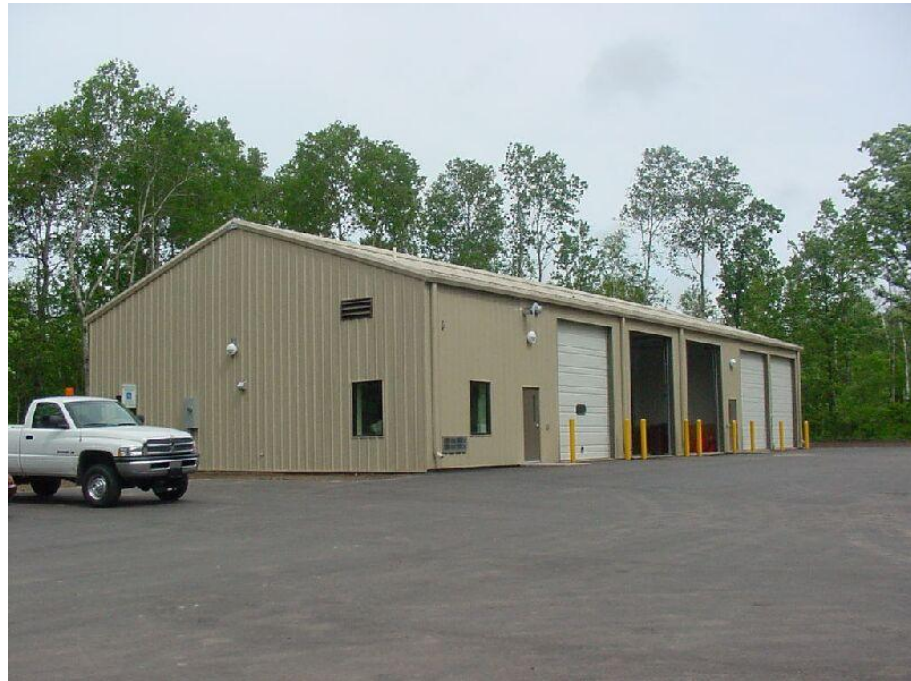
## 12. Maintenance Building

The maintenance department is in need of a facility solely dedicated to housing the maintenance department. This facility should include office space and a large garage for the storage, repair and maintenance of equipment.

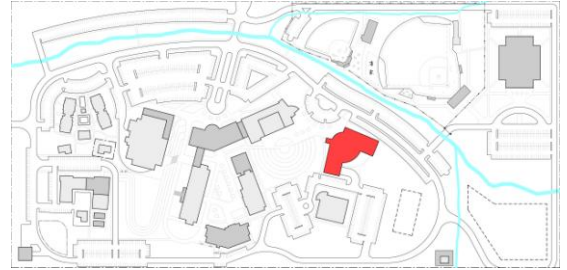
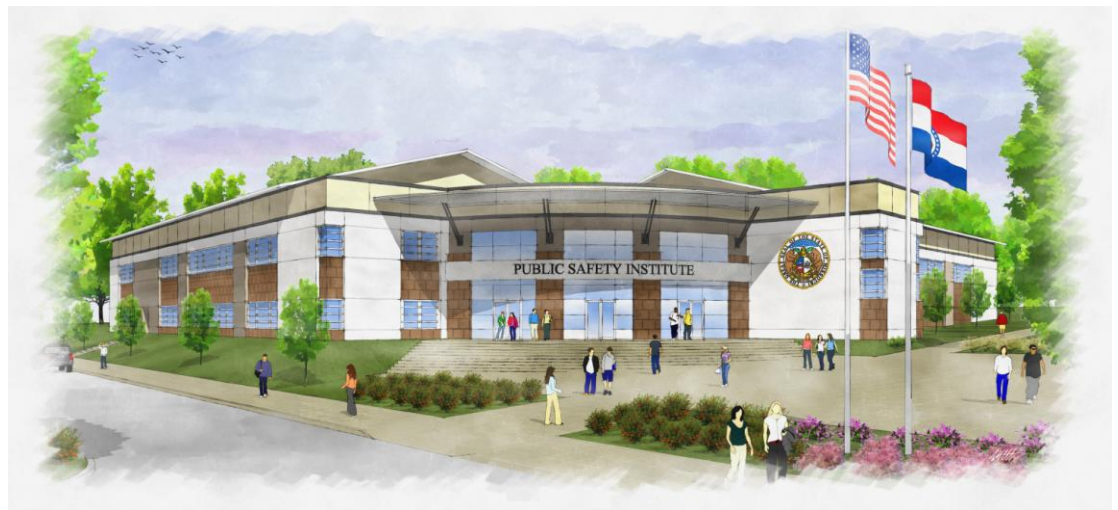
## 17. Public Safety Institute

The academic departments of Fire Science, Law Enforcement, Public Safety Academy and the Campus Police Department are currently housed in multiple areas throughout the Three Rivers campus. Learning activities take place in multiple buildings and also sectioned off parking lots.

Should funding be available from state and federal sources, the building may also be used as a hub for Southeast Missouri disaster relief. Classrooms, training areas, storage, computer labs, indoor underground shooting range, campus police department, and the campus I.T. department are all services that should be designed into this building.

Exterior spaces would include a helipad, burn tower, deep well, training space, adequate parking, and easy public access.

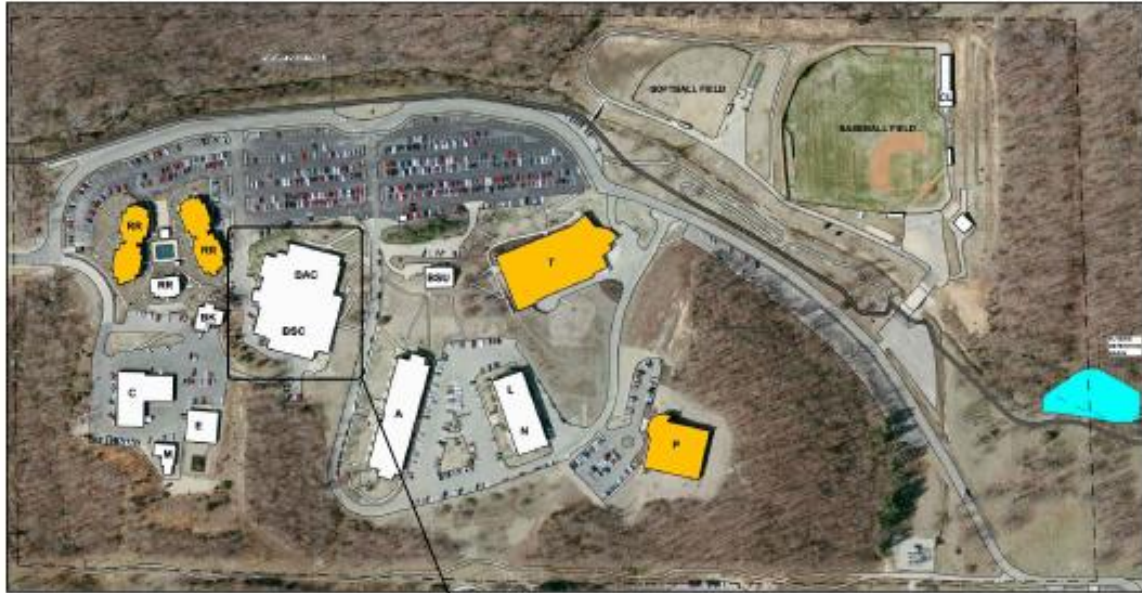
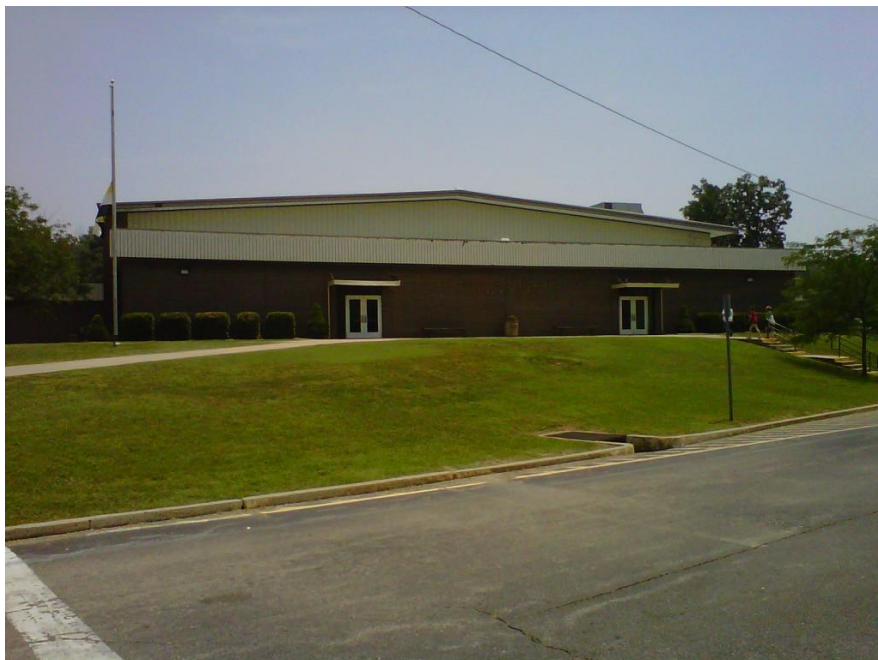
BESS ACTIVITY / STUDENT CENTER

Underground 1,000 amp 480 volt electrical service enters the building at the SW corner. This provides power to the gymnasium, lobby, and locker room areas. Underground 225 amp 480 volt electrical service enters the building on the east side and provides power to the kitchen and entire back (east) side and north addition. The east mechanical room panels have been modified and do not meet code. This should be remedied as soon as possible. Various cover plates are missing throughout the building and should be replaced.

Gymnasium lighting was replaced recently and works well. The lobby lighting is 2x4 fluorescents with prismatic lenses that do not meet the need of the space. Lighting in the Student Lounge was replaced when that area was remodeled. It serves the need and character of the space. Ceiling fluorescents remain in place in this area when needed. Overall office lighting is typical of the campus but very poor light quality.

Many parts of the building are in satisfactory condition with normal wear and tear and little remodeling during the building’s lifespan. Areas that have been remodeled appear new and clean. Original areas such as the entrances, lobby, and gymnasium are in need of attention. The gymnasium lobby could especially use a facelift.

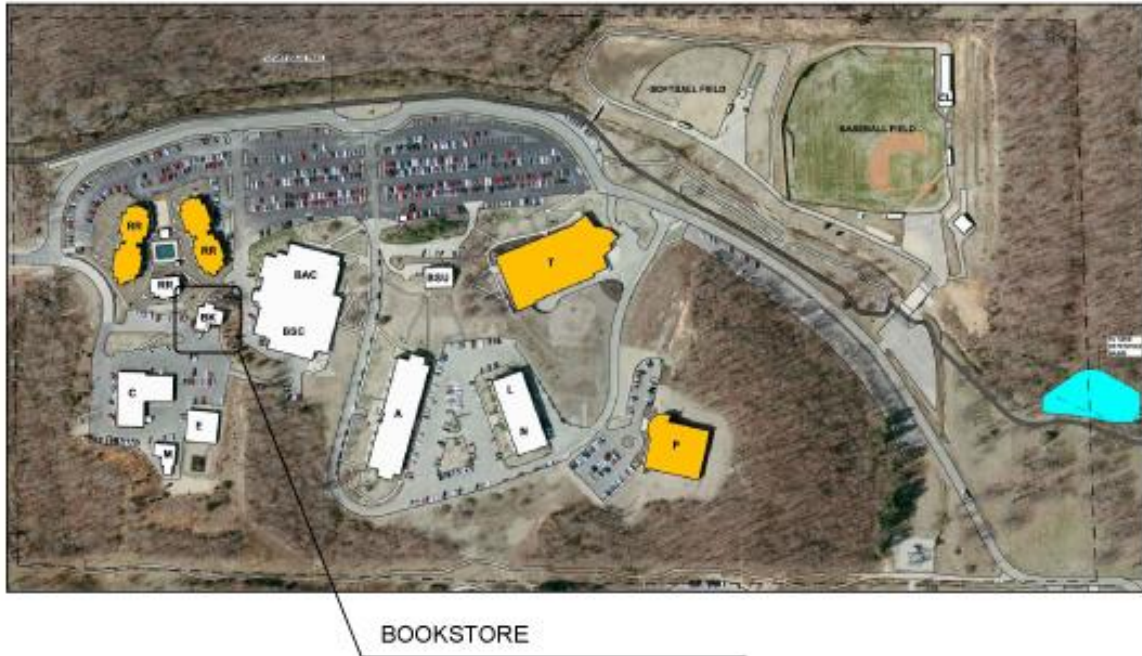
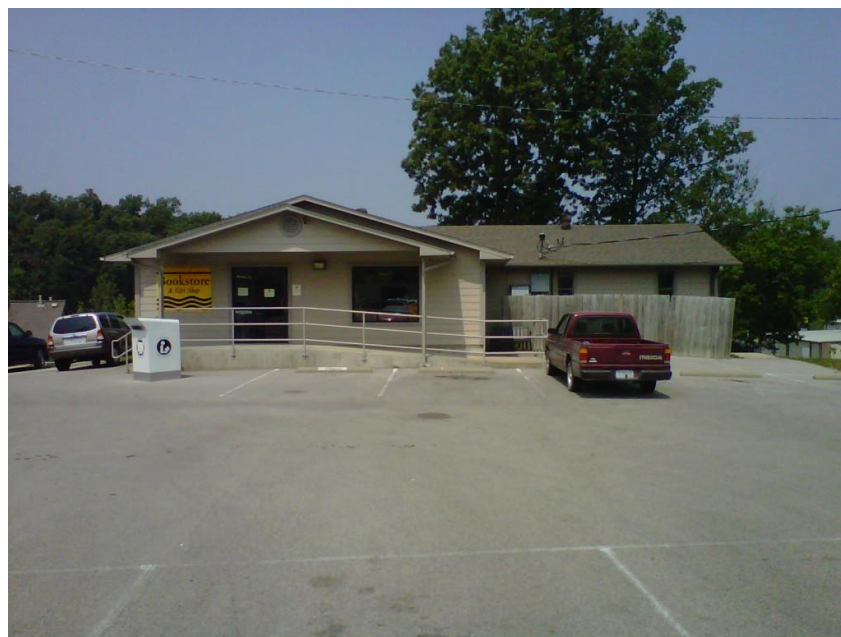
Building has 400 amp 240 volt overhead electrical service. Power appears adequate for the building's current use. This is the only building on campus with overhead electric. Should a renovation occur, going underground is recommended. Service enters on the front of the building behind a wood screen fence.

Most windows are operable and in good condition. One window on the lower level is in a window well and not in good shape. It appears to be nothing more than a basement storm window. One window on the lower level is where a door was previously. It has obviously been changed and does not match any others in the entire building.

The building consists of the original dormitory structure and a one story building addition on the upper level used as retail space. The carpeting has been spliced showing the obvious building connection location. There is a trip hazard at this location on the interior as well. Building appears to be in good structural shape overall.

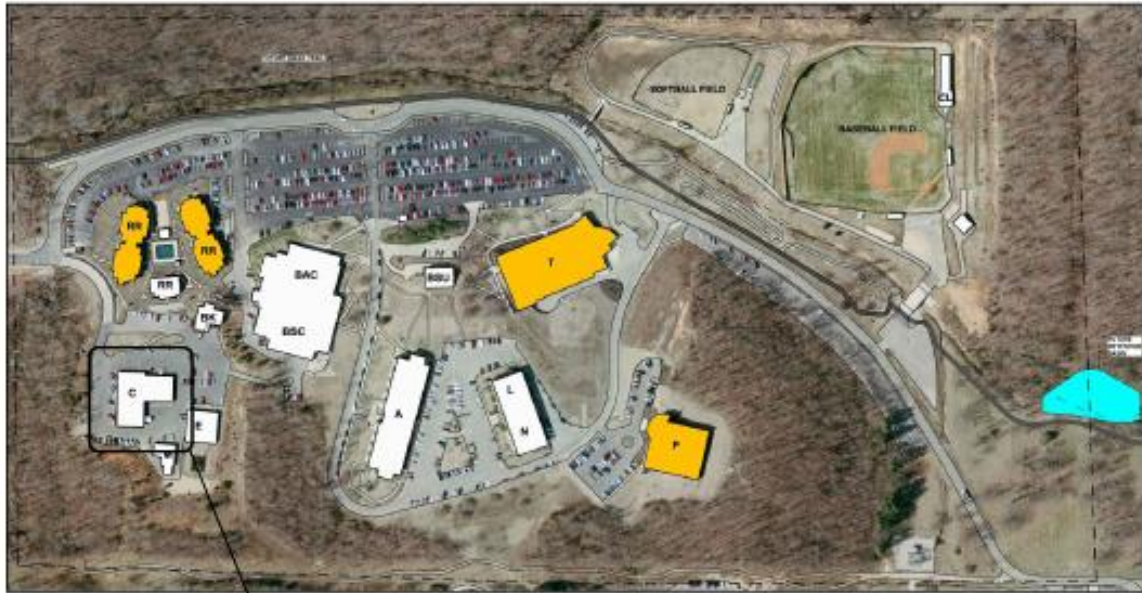
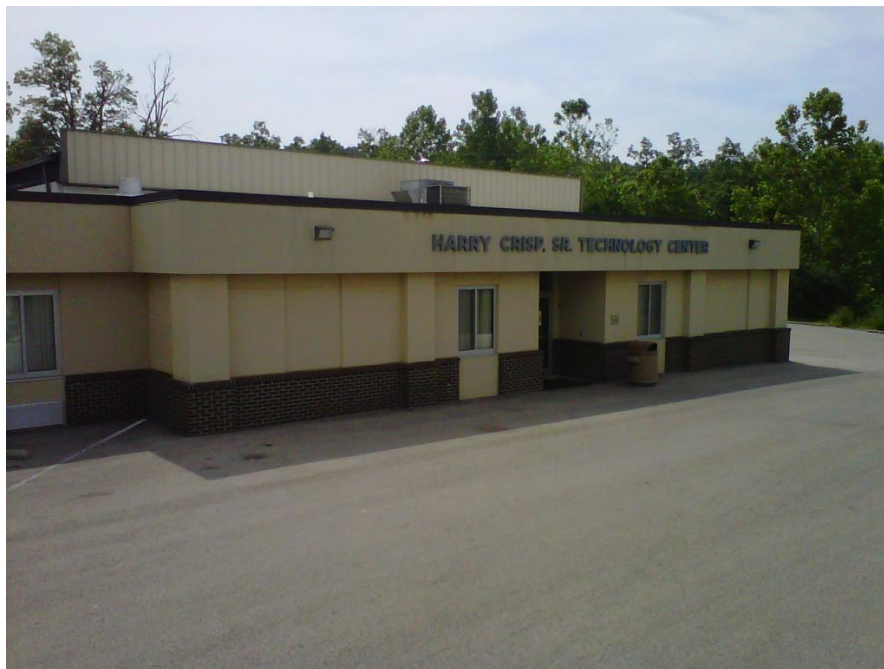
CRISP TECHNOLOGY CENTER

There is very little roof insulation in the building, both the original construction and addition. The building climate is controlled by central air in the original building and front addition except for classroom 103. These units are all electric. One unit does not have a fresh air return which does not meet code. The east addition is controlled by PTAC units that do not provide adequate air conditioning. With the heat generated by the computer labs these rooms can be quite warm. There is gas service to the building but very little is run on this utility.

Decent condition. Windows are in the building addition primarily and are operable sliders. There are skylights in the original building that bring light into the garage and also above the lay-in ceilings of several classrooms.

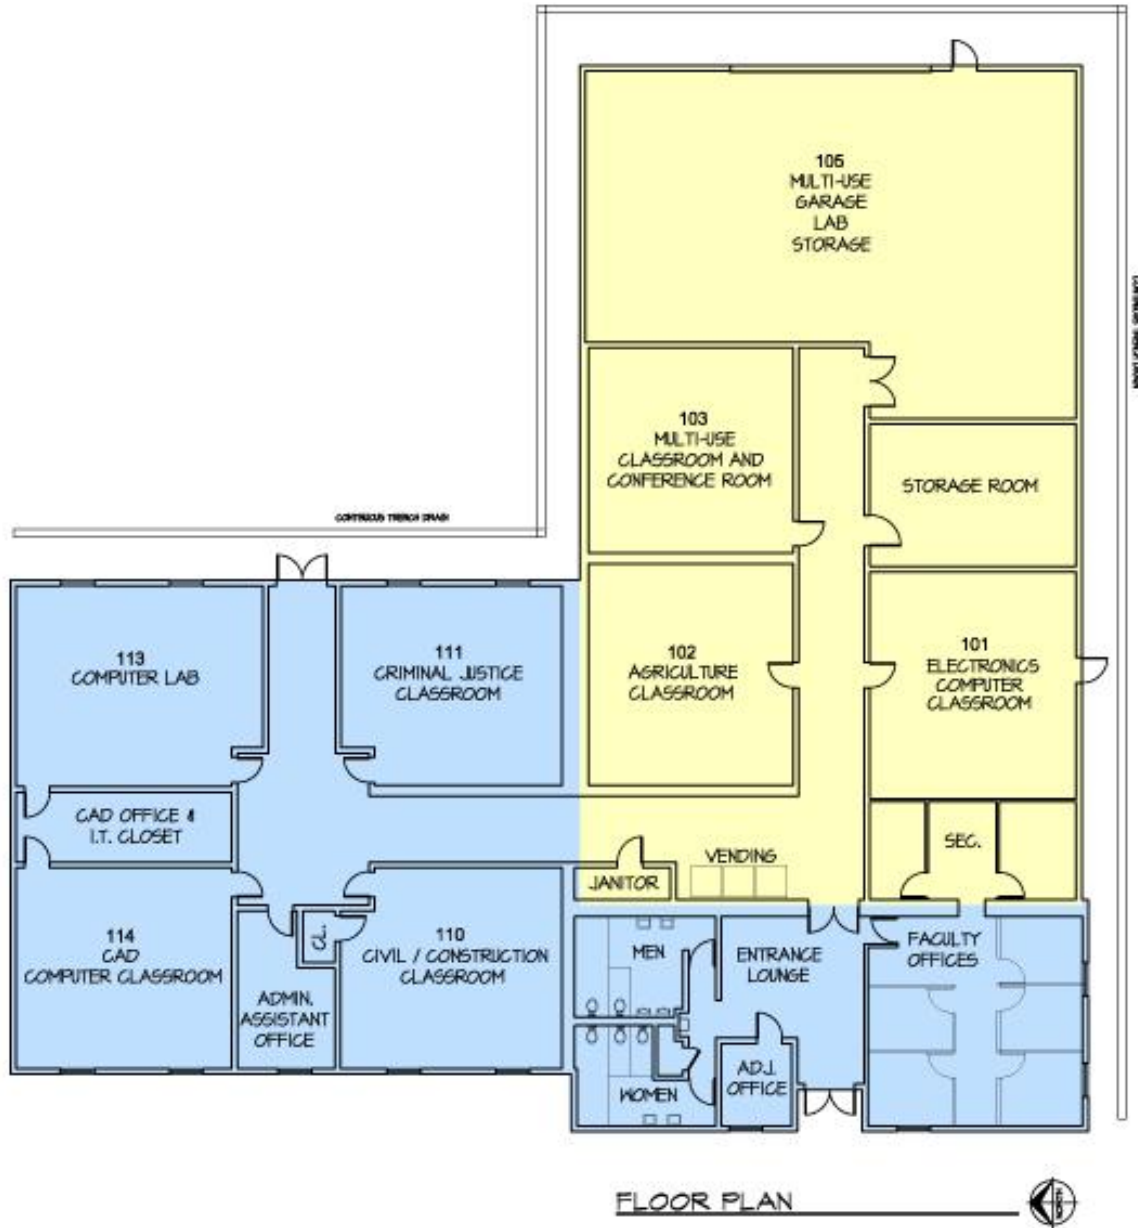
Yellow: Original Construction

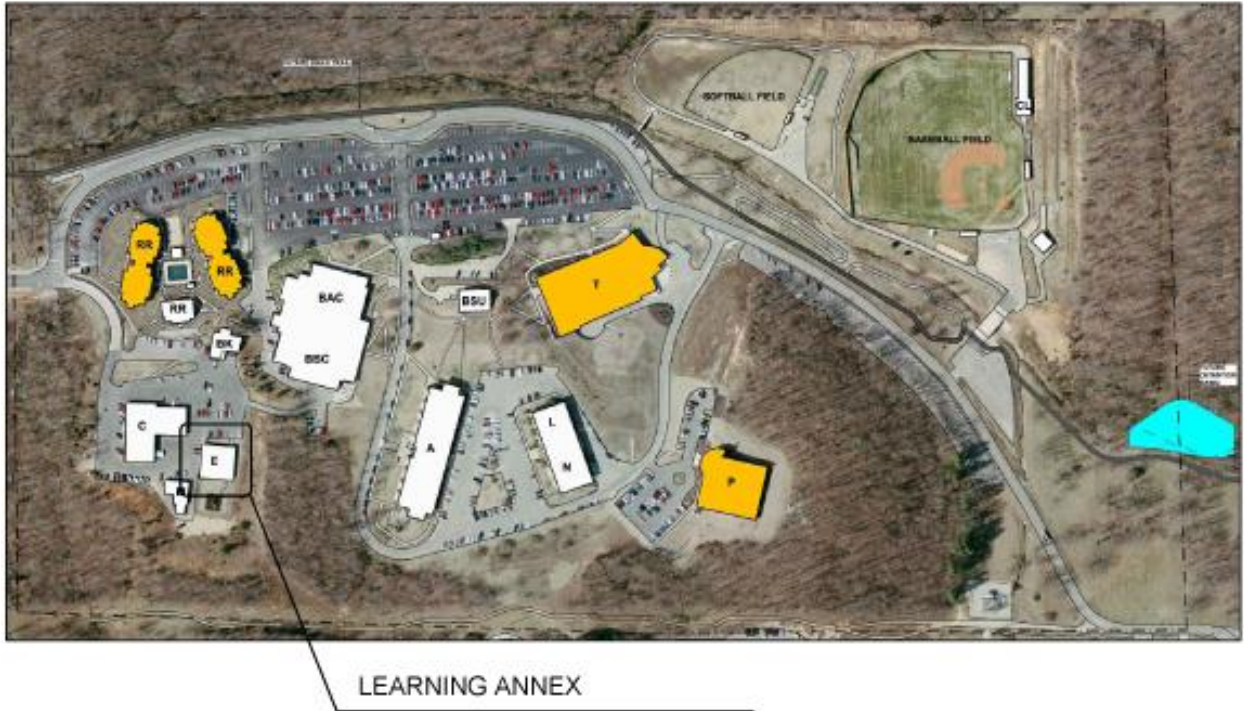
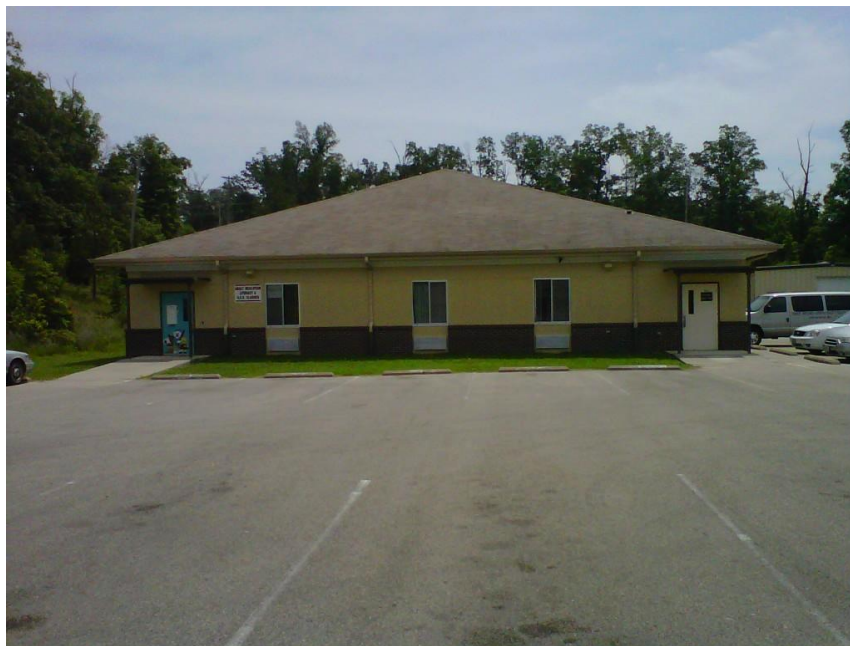
1. Electrical Systems	1	2	3	4	5
The building has 400 amp underground electrical service. This is small but appears adequate for the current use of the building.

2. HVAC Systems	1	2	3	4	5
PTAC units are utilized at most windows. This is the only system used for heating and cooling the building. This system of climate control is inadequate when heat generating equipment such as computers are used and the building is occupied.

15. Maintenance/Upkeep	1	2	3	4	5
The interior of the building is extremely cluttered, presumably because of the new use having moved in for quick operation. There are exterior light fixtures with missing housings and not in working condition. Building needs to be planned for its future use and remodeled accordingly.

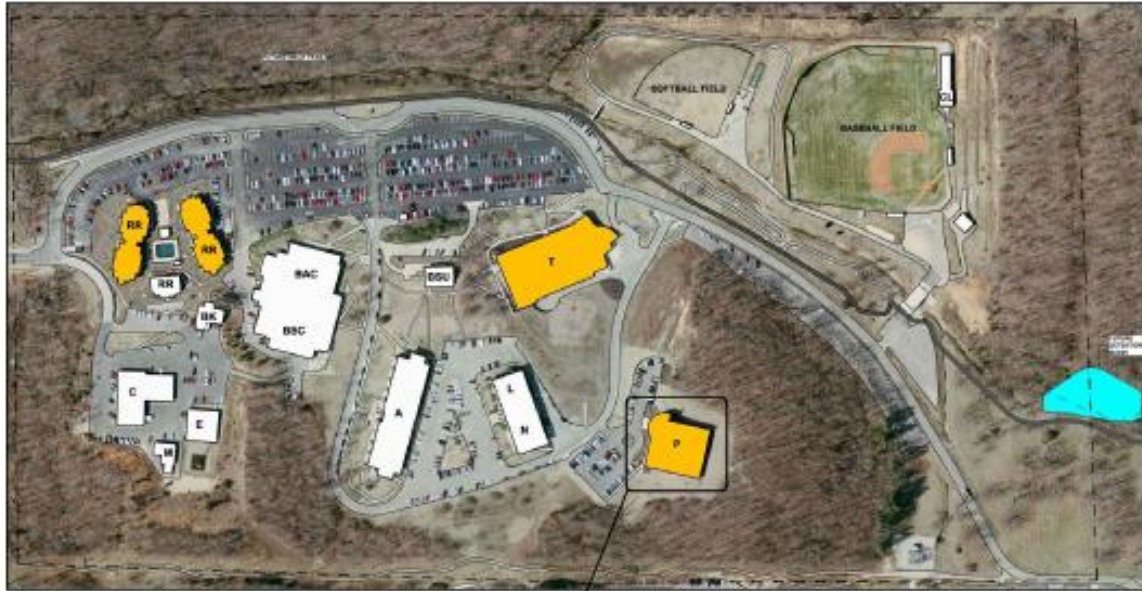
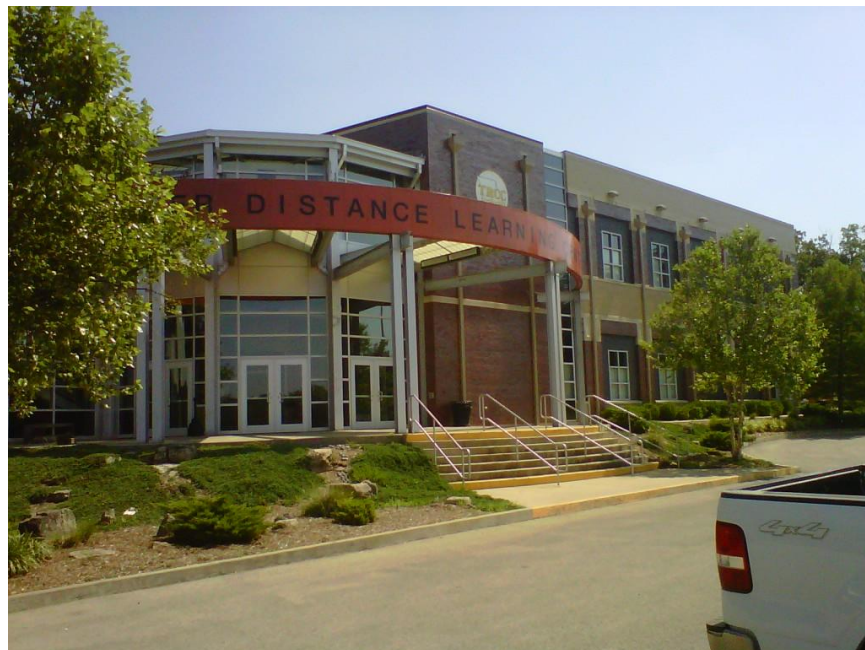
PORTER DISTANCE LEARNING CENTER

Electrical service is underground and 1,200 amp 480 volt. This service is adequate for the building as currently used and should not need upgrading for any reason.

There is some wear and tear on the building but nothing beyond normal. It appears that protective corner trim has been added to most drywall outside corners since the building was constructed. Excess glue was used and is exposed at each location creating an unsightly installation. The painted steel on the exterior by the entrance is peeling and needs to be removed before repainting for a quality application.

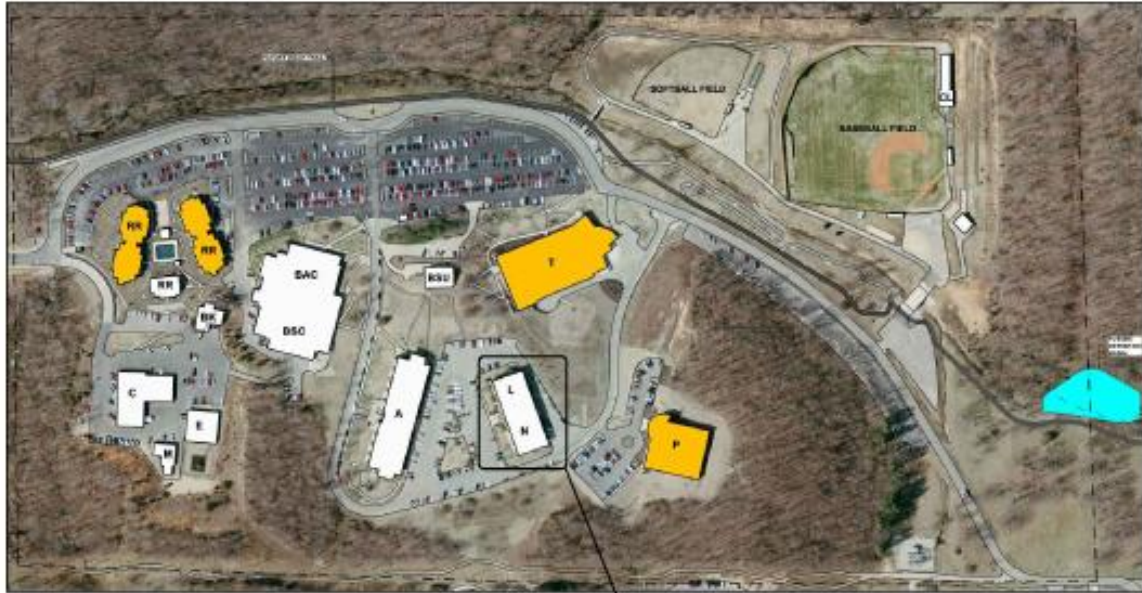
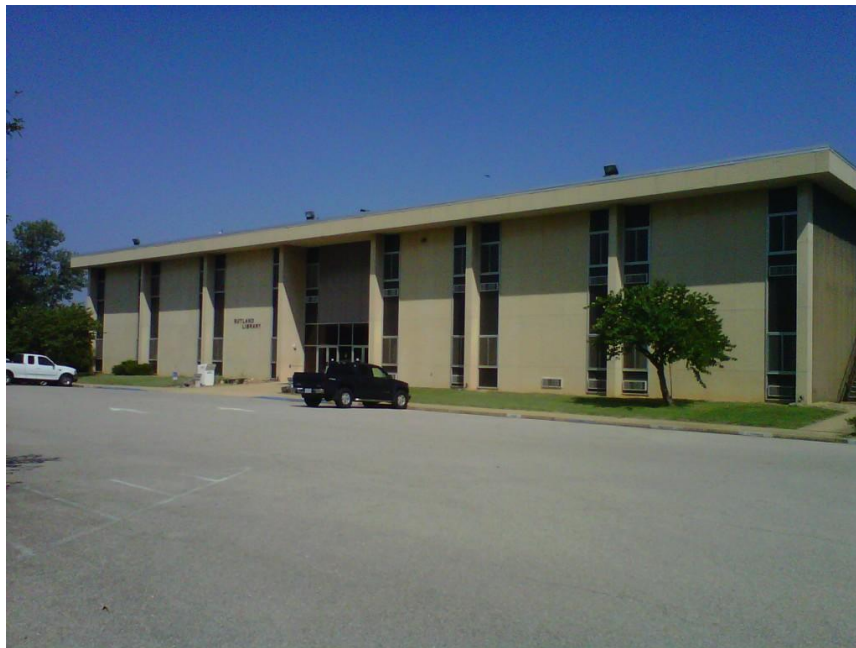
RUTLAND LIBRARY BUILDING

Underground electrical service to the building is 1200 amp 480 volt. This should be adequate for the building’s foreseeable future. Should HVAC units be switched from electric to gas more power will be available to the building as well.

The west wing and central core areas are taken care of by roof top units. The east wing is served by PTAC units through the walls. The original boiler/chiller system was removed at some point in the past. This opened up space in the mechanical room for storage. The PTAC units are not a good source for climate control due to no fresh air, noise, and no disbursement of air throughout the space. It is recommended to eliminate this type of unit throughout the campus as renovation occurs.

With the nursing program moving out of the east wing this area will need a thorough renovation to make usable. Due to this there has been little upkeep in the past year. The remainder of the building is also in need of renovation. Though kept open and relatively clean there is significant wear from general usage over the past 30 plus years.

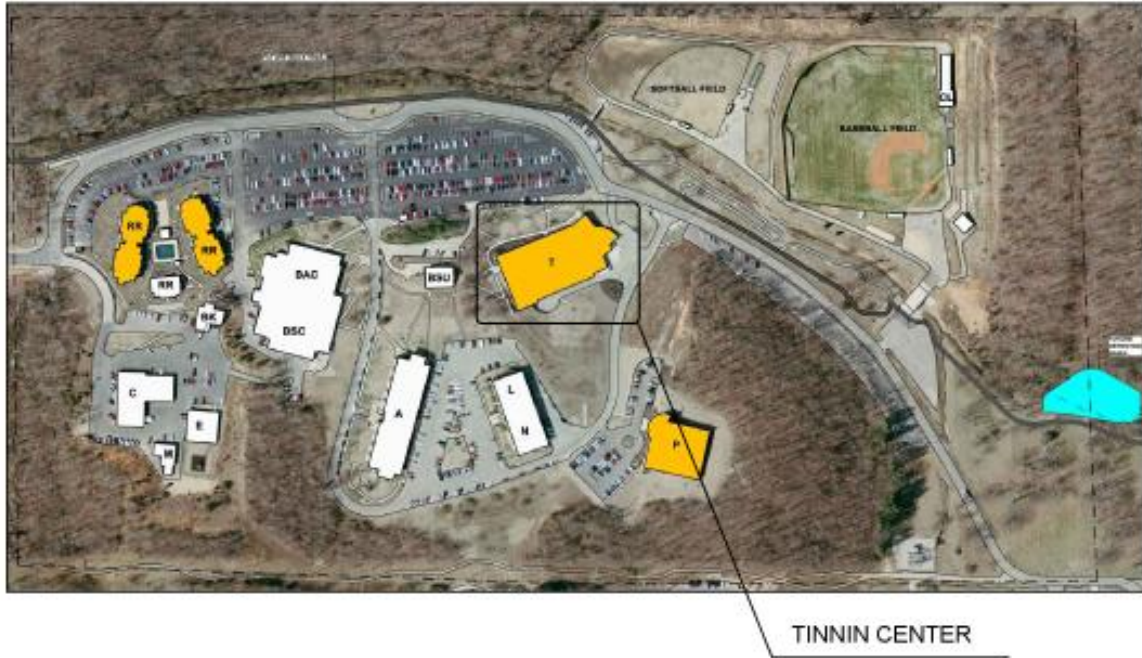
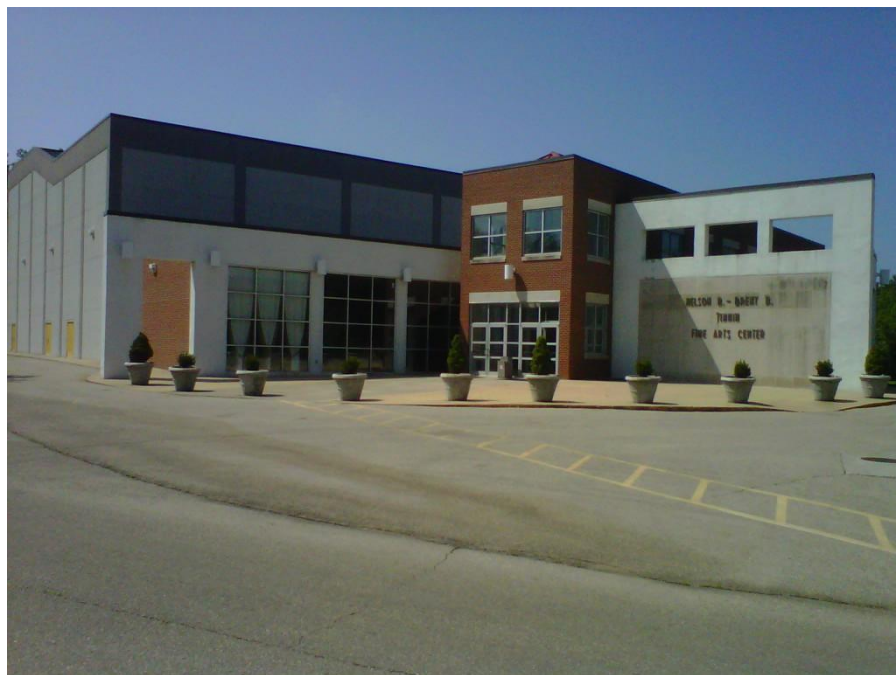
There are two sets of electrical panels. In the mechanical room on the east side of the theater there is a 600 amp 208 volt service panel and in the main mechanical room adjacent to the shop there is a 2000 amp 480 volt panel. This should be sufficient power for the building for the foreseeable future. A transformer sits on the east side of the building toward the south corner.

There are a number of rooftop mechanical units serving the theater, corridors, and other central areas of the building. The condition of these units was undetermined but thought to be in reasonable condition based on their age and should they have had routine maintenance. The units also take advantage of gas in that they will save on utility costs. There are PTAC units in most of the rooms along the west side on both floors. These units do not offer the necessary fresh air requirements and are a poor design for college building construction. It appeared that several PTAC units were in the process of being replaced but taking an inordinate amount of time. This was noticed based on site visits covering a several month time span leaving open gaps in the exterior wall.

The building is a steel post and beam structure. The floors are steel bar joists holding a metal deck filled with concrete. This is a conventional structural system and one that should work well for years to come. The roof has a low slope, tapered insulation, and an EPDM membrane. There are many leaks and it appears the roof has outlived its lifespan. The building being 15 years old this is not unexpected. However, the roof may need to be fully replaced at a fairly significant cost.
