Facilities Master Plan  
2013

Prepared by:  
Dille & Traxel, LLC  
Architecture and Planning  
4061 Highway PP, Ste. 2  
Poplar Bluff, MO 63901

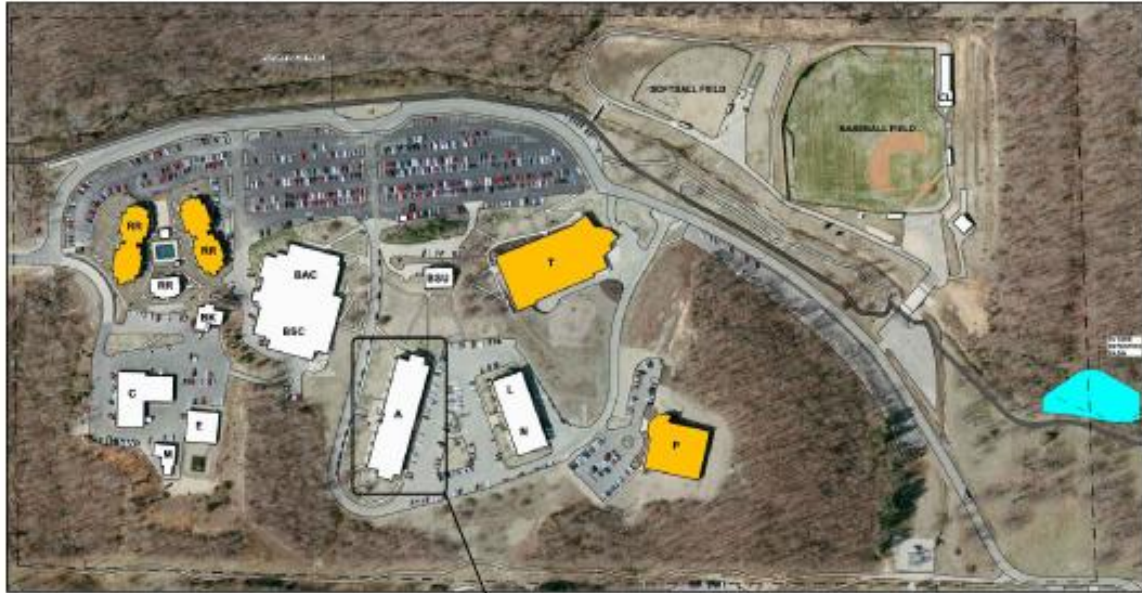
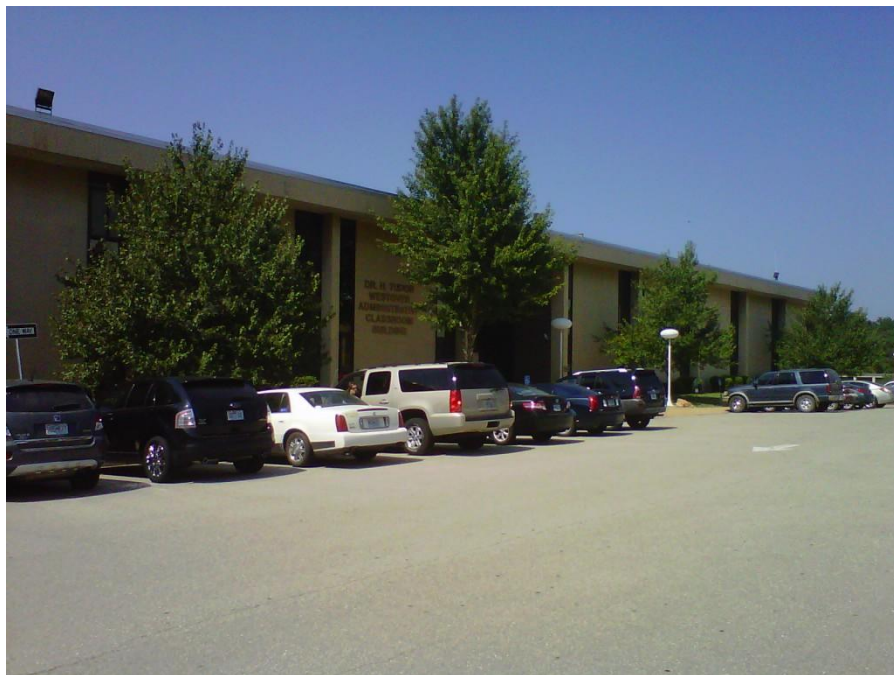
WESTOVER CLASSROOM BUILDING

Electrical service is provided underground and is 3000 amp 480 volt. This amount of power should be adequate for the future should the use of the building remain the same.

The original boiler/chiller system for the building has been replaced. There are roof top units and two ground mounted units on the back (west) side of the building that provide climate control for the entire building. These units are gas powered and appear to be in good working condition. The corridors in the building do not appear to have any supply air which is rather odd.

Windows are in satisfactory condition and operable.

Restrooms are in satisfactory condition but dated. Entrances need to be modified to meet ADA guidelines.

Circulation throughout the building works well. The lobby is large enough for its use and the end entrances appear to work well. Doors may need maintenance on the west end as they seem to receive the most wear.

The building is over thirty years old and has had no major changes to its exterior. The style of the building is one that easily dates its origination. There is no major issues with the condition of the exterior but there are some things that could be done to modernize the building. Exterior lighting upgrades and entranceway and lobby remodeling are two places to start. The building character is that of an older building but could be changed without a major renovation to provide a fresh image.

Many of the doors are chewed up and need to be replaced. Normal wear and tear without remodeling has caused this and other wall gouges to accumulate. Overall upkeep appears to be adequate for what is available.

There are no fire alarm or fire suppression systems in the building. It is recommended that a fire alarm system be installed and tied into a campus wide system and monitoring service. Emergency lighting and exit signs are dated and only some are fully operational. It is recommended these be replaced as soon as possible.
